# **OptimFlush**

SATOFSHFS2

Floor-standing Rimless Toilet

## **INSTALLATION INSTRUCTIONS**

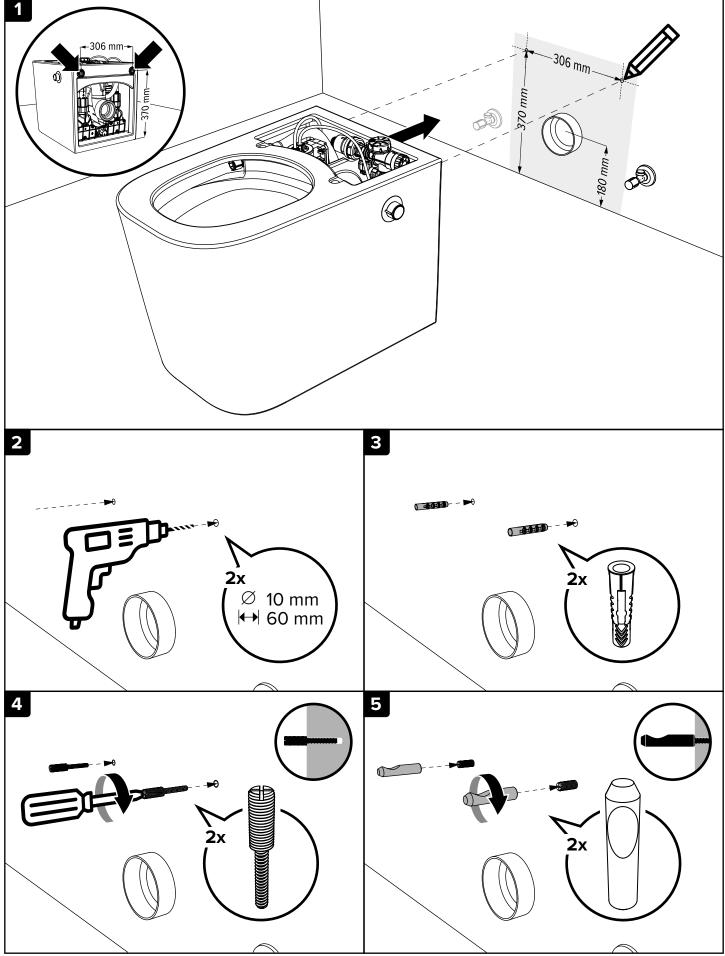
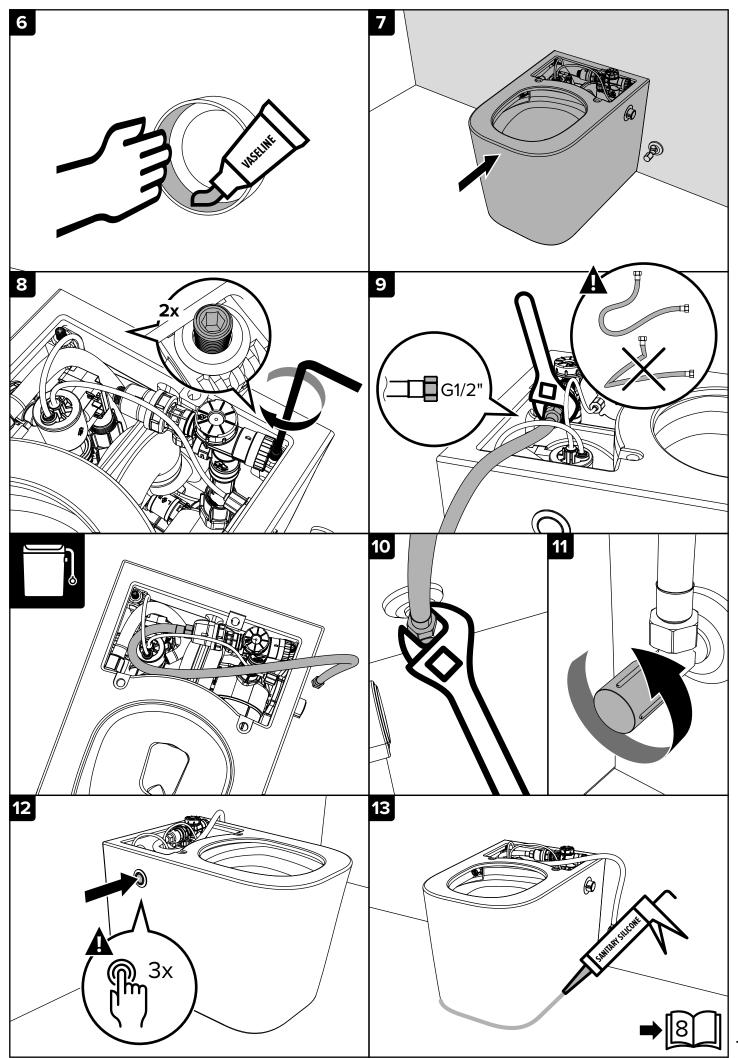
#### **TOILET INSTALLATION**

NOTE: Mounting surface must be clean and level before toilet is installed!

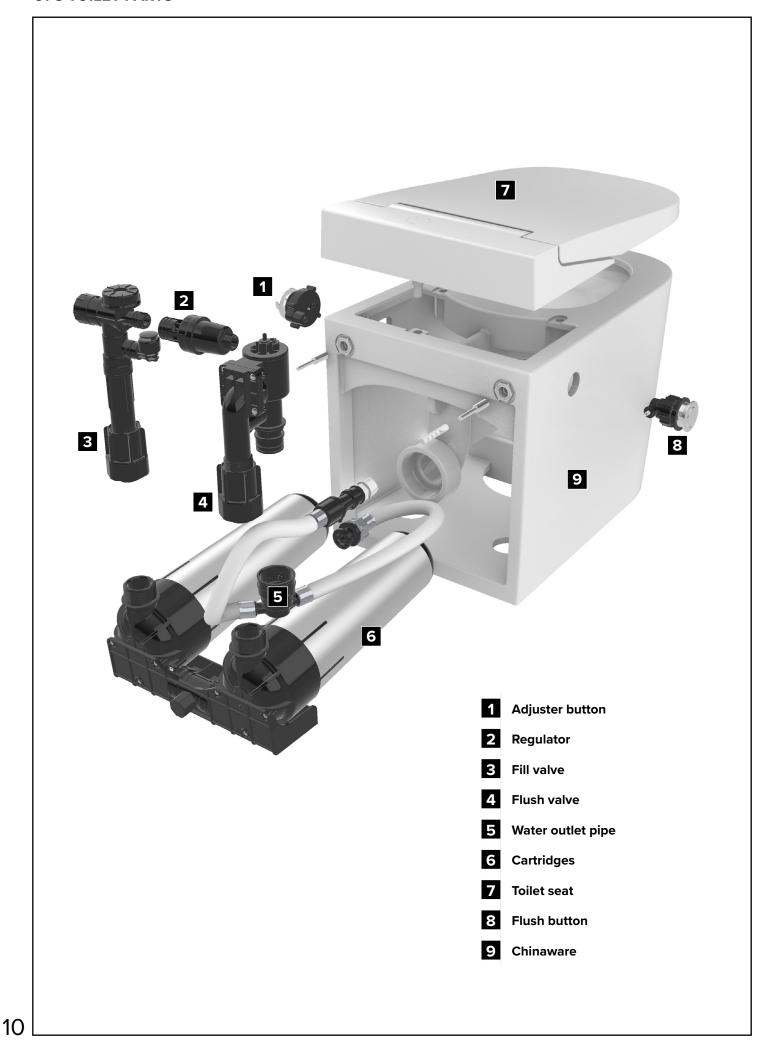
#### **OFS TOILET PARTS**

No	Part Name	Part Number	Usage
1	Adjuster button	NDSATOFSHFS2AB	1
2	Regulator	999910060150	1
3	Fill valve	112070031020	1
4	Flush valve deck & core	112070031023 NDSATOFSHFS2FV	1
5	Water outlet pipe	NDSATOFSHFS2OP	1
6	Cartridges	NDSATOFSHFS2CA	1
7	Toilet seat	NDSATOFSHFS2SE	1
8	Hydraulic flush button	112070031021	1
9	Chinaware - ceramic toilet	NDSATOFSHFS2WC	1
